Project Rulison: Pre-Shot Predictions of Structural Effects

**PROJECT RULISON:
Pre-Shot Predictions
of Structural Effects**

John A. Blume & Associates
Research Division
San Francisco, California

March 1969

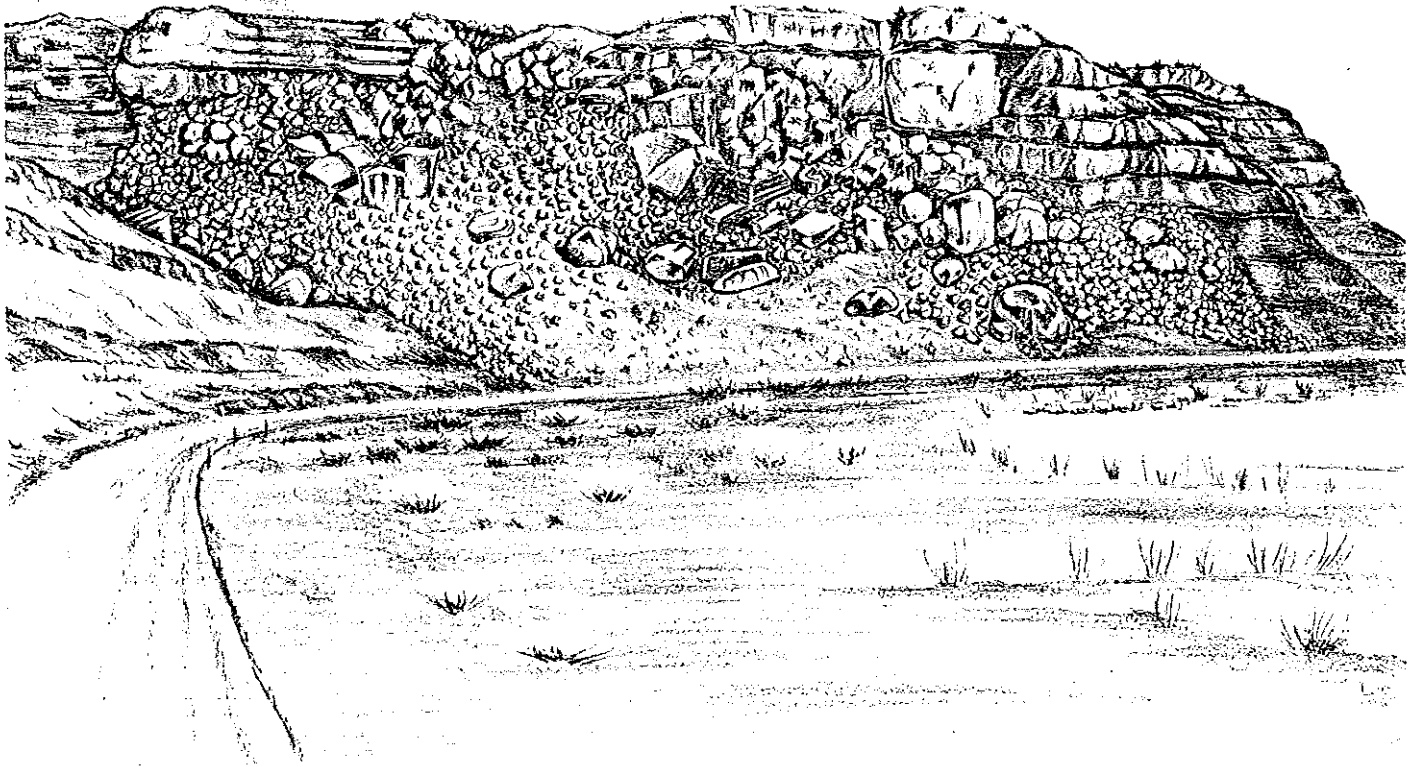
View of De Beque Canyon, Colorado landslide, showing features of slope instability in the canyon. Interstate Highway 70 is shown extending from the lower left-hand-corner across the toe of the slide. The Colorado river is below the highway to the right of center.

The rim rock collapse is believed to have taken place in 1929. The slide continues to be a hazard, as it is a source of rock falls onto the highway and a chronic highway maintenance problem.
